INDOOR AIR QUALITY ASSESSMENT

**Bridgewater Elementary School
500 South Street
Bridgewater, Massachusetts**

Prepared by:
Massachusetts Department of Public Health
Center for Environmental Health
Bureau of Environmental Health Assessment
Emergency Response/Indoor Air Quality Program
April 2004

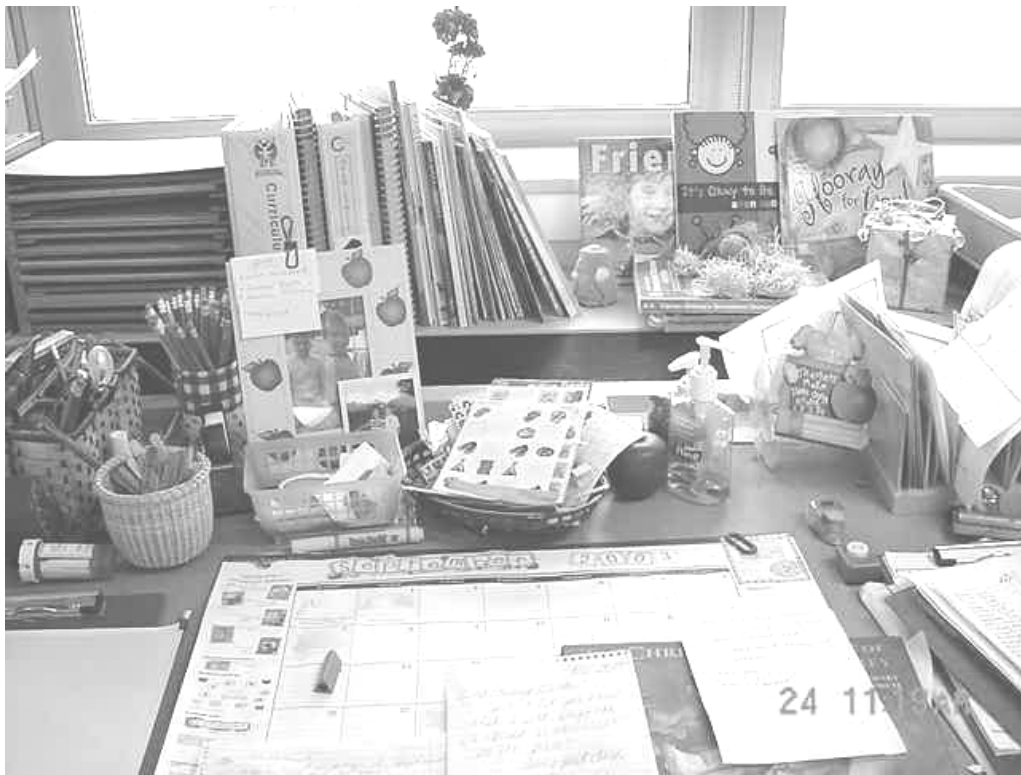
Picture 1

Fresh air in classrooms is supplied by a unit ventilator (univent) system. Univents draw air from outdoors through a fresh air intake located on the exterior walls of the building and return air through an air intake located at the base of each unit ([Figure 1](#)). Univents in the first (ground) floor are ceiling mounted in most areas, with fresh air intakes located above windows on the exterior walls. Several areas, including the library and computer room, draw fresh air from vents located in the roof. Fresh and return air are mixed, filtered, heated and provided to classrooms through an air diffuser located in the top of the unit. Obstructions to airflow, such as papers and books stored on top of univents and bookcases and carts and desks placed in front of univent returns, were seen

in a number of classrooms (Picture 1). In order for univents to provide fresh air as designed, intakes must remain free of obstructions. The univent in room 117 was not operating during the assessment and was on order to be repaired.

Accumulated Items in Classroom Obstructing Univent

3. Remove all blockages from univents and exhaust vents to ensure adequate airflow.
4. Maximize air exchange. The BEHA recommends that all ventilation systems that are operable throughout the building (e.g., gym, auditorium, classrooms) operate continuously during periods of school occupancy independent of thermostat control.

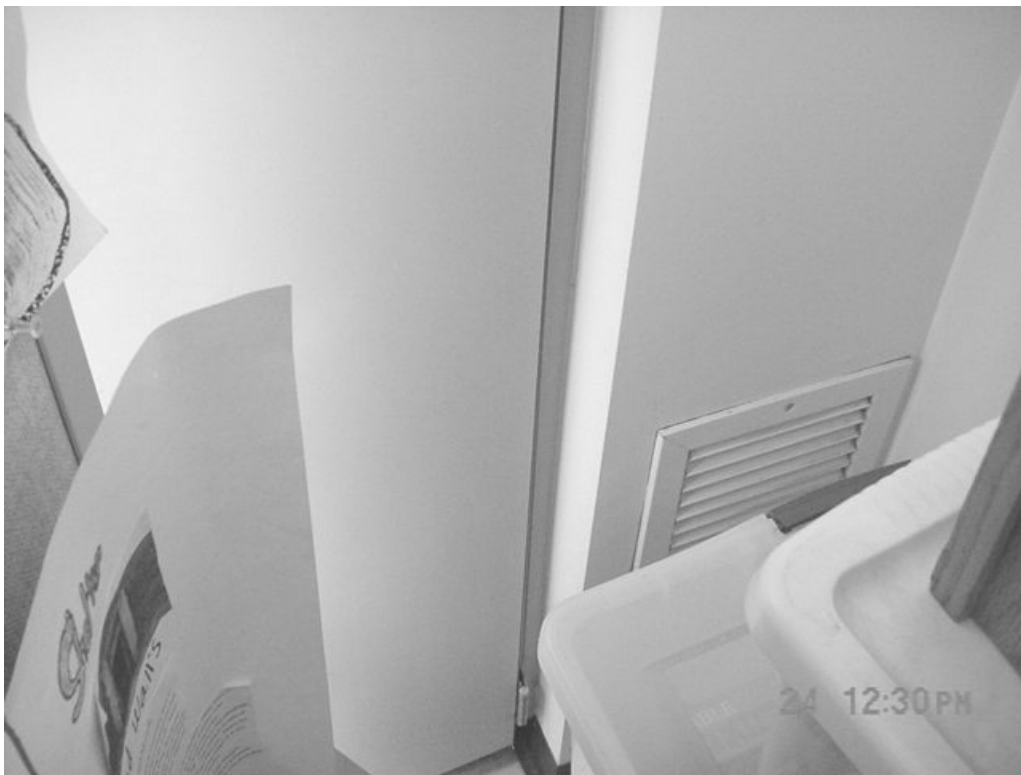
Picture 2

The mechanical exhaust ventilation system in each classroom consists of ducted, grated wall vents. Exhaust vents were found obstructed by cabinets, desks, or other items (Picture 2). As with the univents, exhaust vents must also remain free of obstructions in order to function as designed.

Obstructed Exhaust Vent in Classroom

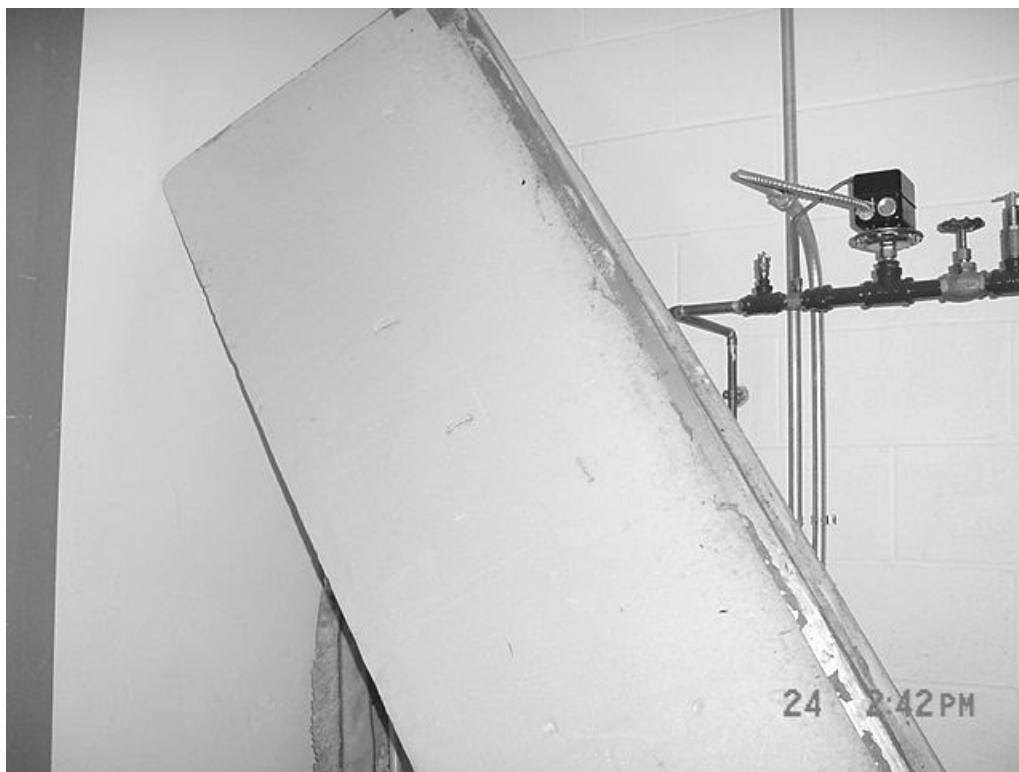
Picture 3

During the assessment, BEHA staff found an insulation sheet in a storage closet that appeared to be colonized with mold (Picture 3). The storage closet also had a noticeable musty odor. BEHA staff recommended that this sheet be removed from the BES. In a subsequent conversation, BES staff reported that the item removed from the school.

Water Damaged Fiberboard Insulation

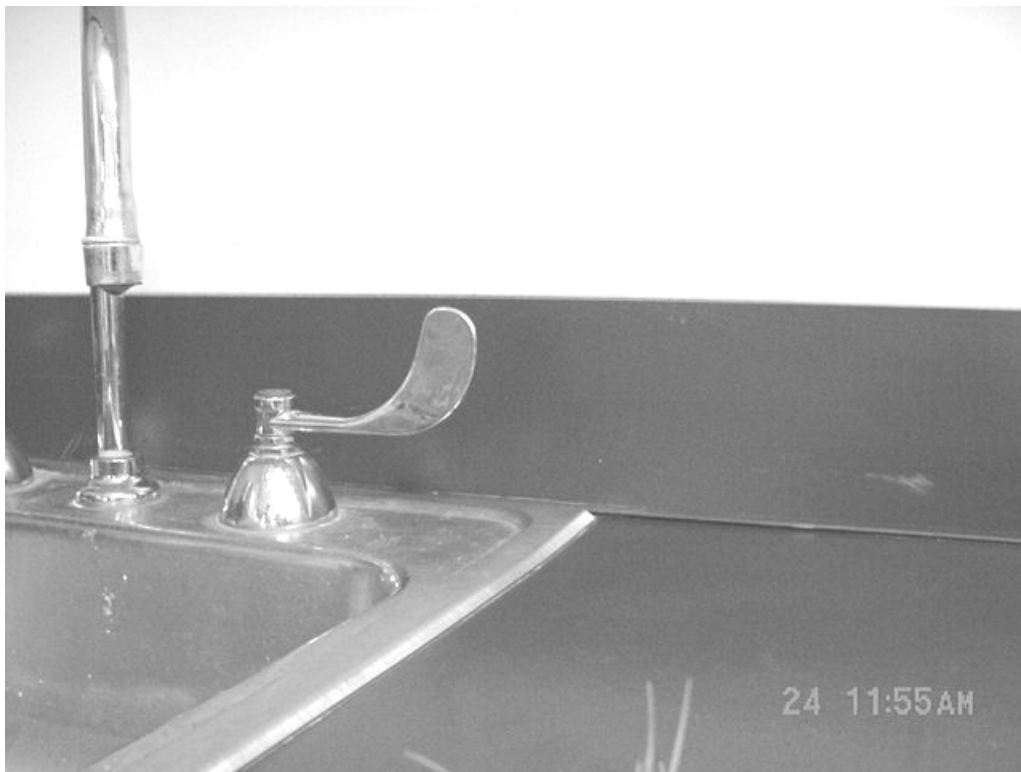
Picture 4

Open seams between the sink countertop and wall were observed in several rooms (Picture 4). If not watertight, water can penetrate through the seam, causing water damage. Water penetration and chronic exposure of porous and wood-based materials can cause these materials to swell and show signs of water damage. Moistened materials that are not dried within 24 to 48 hours can become potential sources for mold growth.

Breach Between In Sink Backsplash

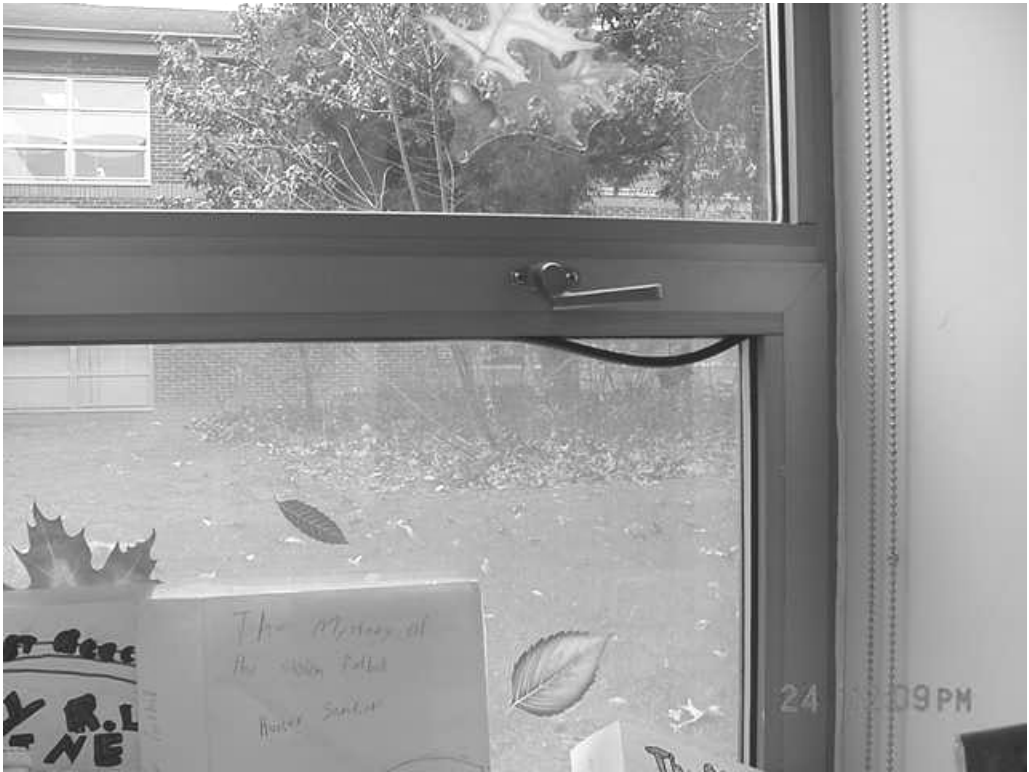
Picture 5

Other sources for water damage were also observed. Caulking around windows was missing/damaged in many areas (Picture 5). Missing caulking can make temperature control difficult. It can also allow water to penetrate the building. Replacement of

Damaged Window Caulking

caulking and repairs of window leaks are necessary to prevent water penetration and subsequent damage to building materials, which can lead to mold growth.

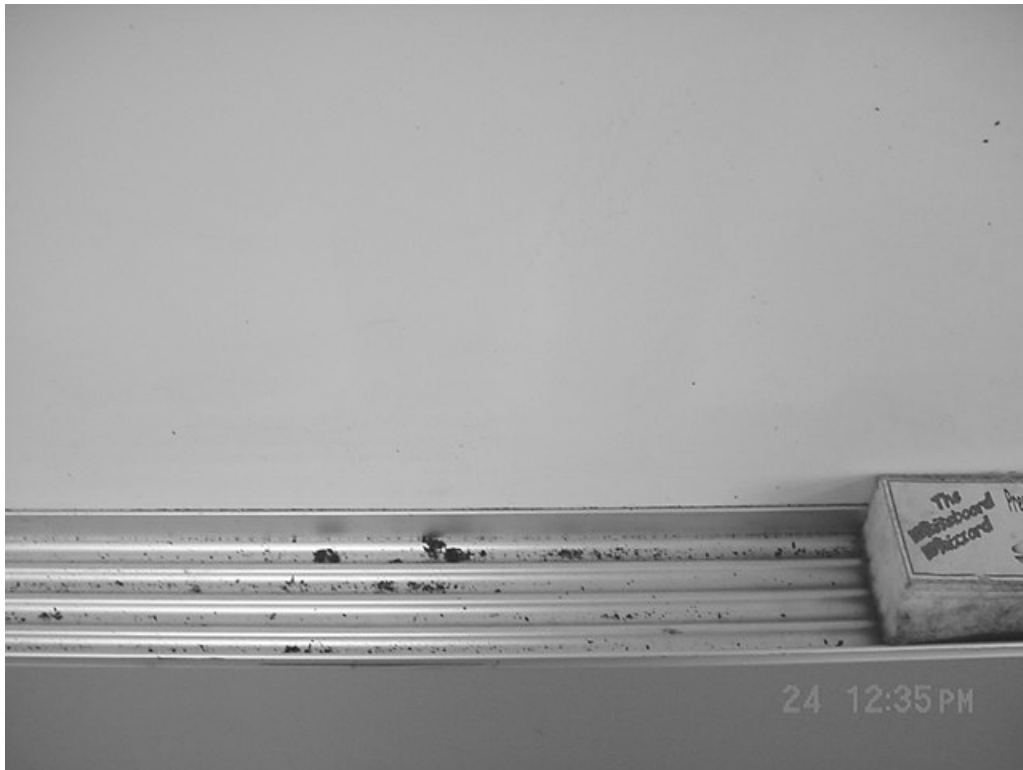
Picture 6

Accumulated Dry Erase Marker Debris

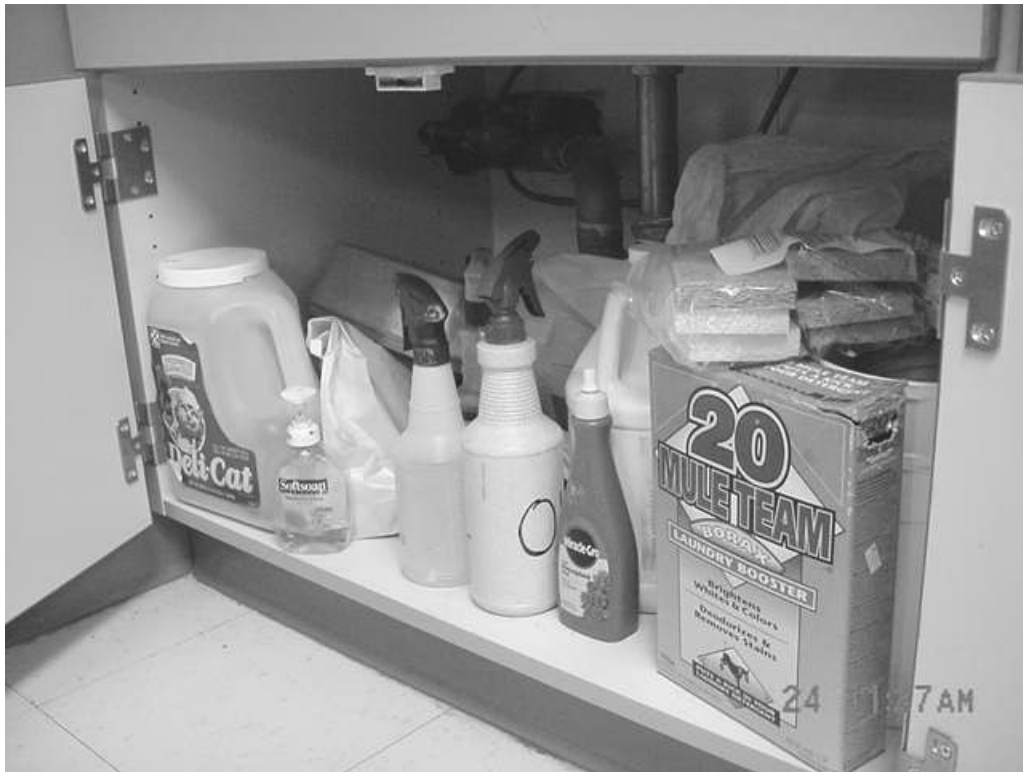
Picture 7

Cleaning products were also found under sinks and on countertops in a number of classrooms (Picture 7). Cleaning products contain chemicals, which can be irritating to the eyes, nose and throat, and should be stored properly and out of the reach of students.

Cleaners Found in a Sink Cabinet

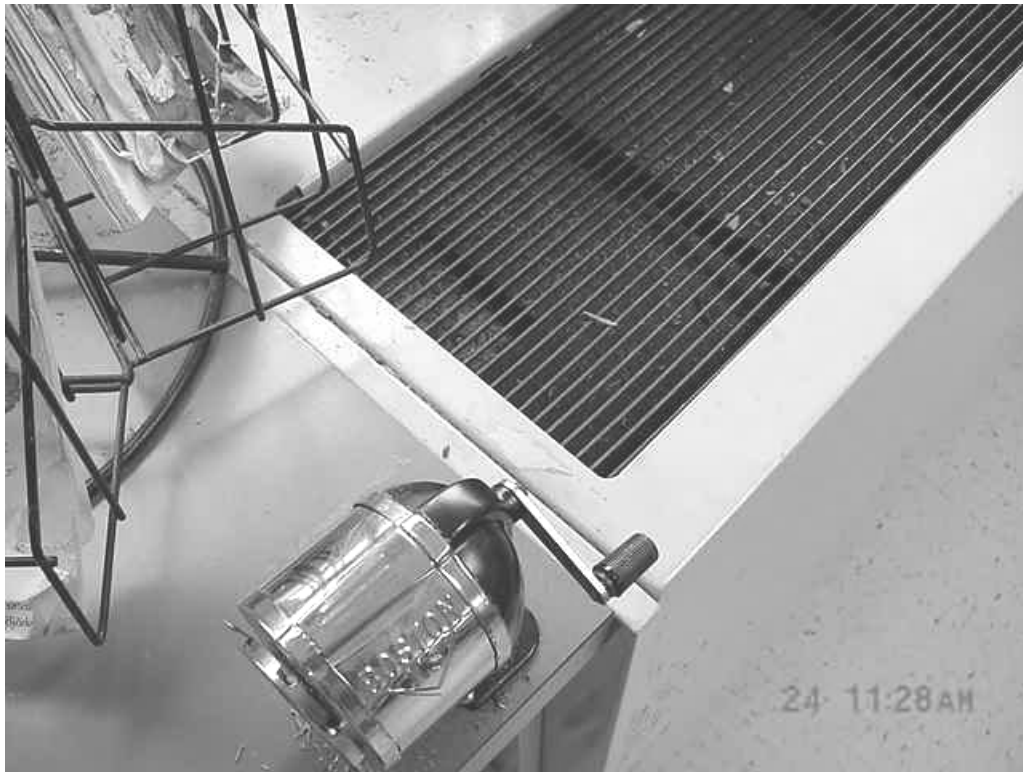
Picture 8

Accumulated chalk dust was noted in some classrooms. Chalk dust is a fine particulate that can easily become aerosolized, irritating eyes and the respiratory system. Similarly, pencil shavings were observed to be accumulating at the base of pencil sharpeners (Picture 8). In many classrooms, pencil sharpeners are stationed on bookcases located in front of windows or near univents. Clay art projects were also placed near windows and on top of univents. Dry clay materials produce dust (Picture 9). Open

Pencil Shavings accumulated at the base of a Pencil Sharpener and Univent

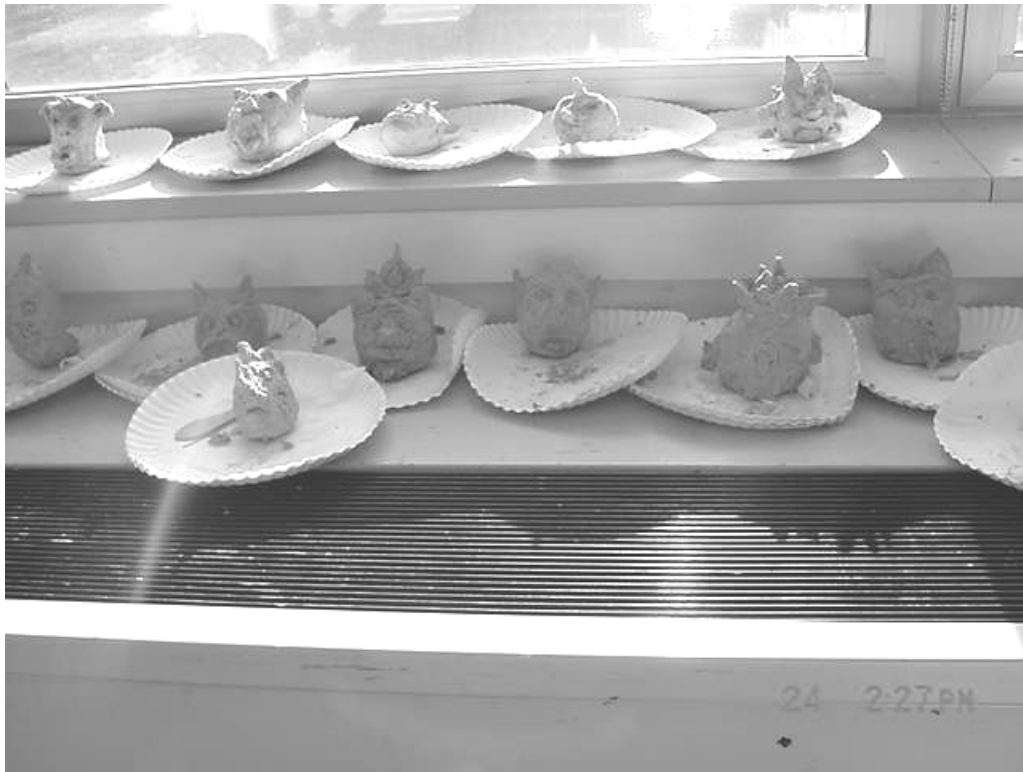
Picture 9

Clay Art projects Drying on Top of Univent

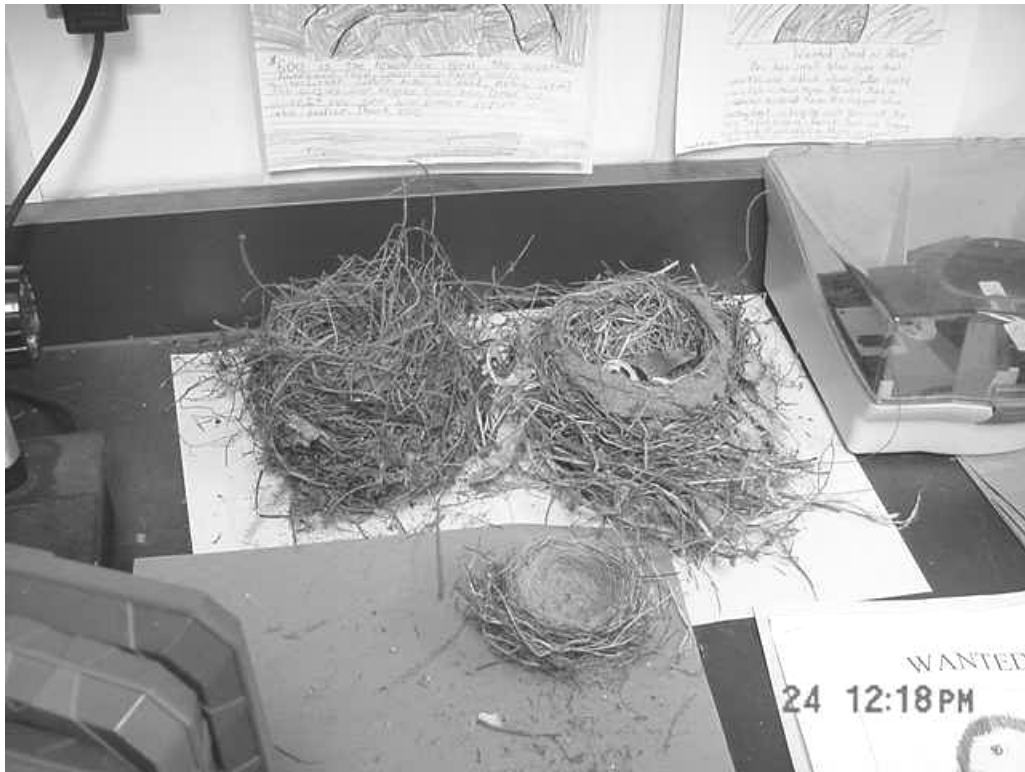
Picture 10

Inactive bird's nests and bird feathers were noted in classrooms and reportedly serve as learning tools (Picture 10). Bird's nests can contain bacteria and may also be a source of allergenic material as can feathers. Feathers and nests should be placed in re-sealable bags to prevent aerosolization of allergenic material. These items should also be located away from univents fresh air diffusers.

Birds' nests

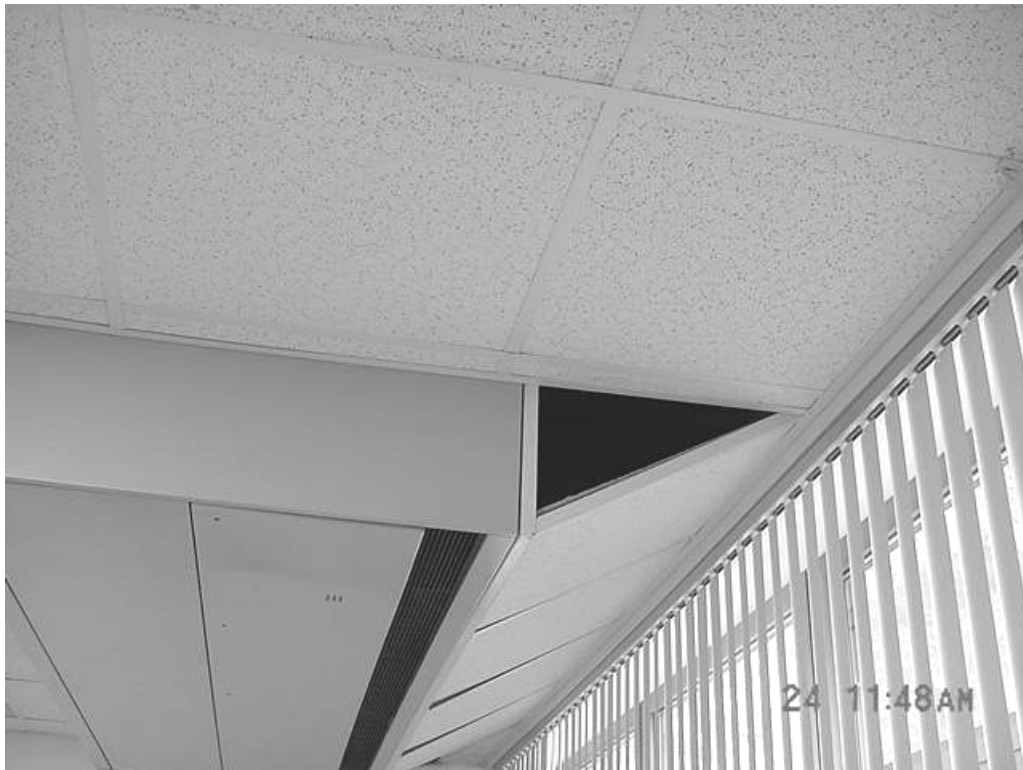
Picture 11

Lastly, several rooms had missing and/or dislodged ceiling tiles (Picture 11). Missing/dislodged ceiling tiles can provide a pathway for the movement of drafts, dusts and particulate matter between rooms and floors. Items were also observed hanging from ceiling tiles. The movement or damage to ceiling tiles can release accumulated dirt, dust and particulates that accumulate in the ceiling plenum into occupied areas. As previously discussed, dust can be irritating to the eyes, nose and respiratory tract. Building occupants should refrain from hanging objects from ceiling tile systems.

7. Replace missing ceiling tiles to prevent the egress of dirt, dust and particulate matter into classrooms. Refrain from hanging objects from ceiling tile system.
